Superfund Five-Year Review Report

Pickettville Road Landfill Jacksonville, Duval County, Florida

Prepared for
U.S. Environmental Protection Agency, Region IV
September 1999

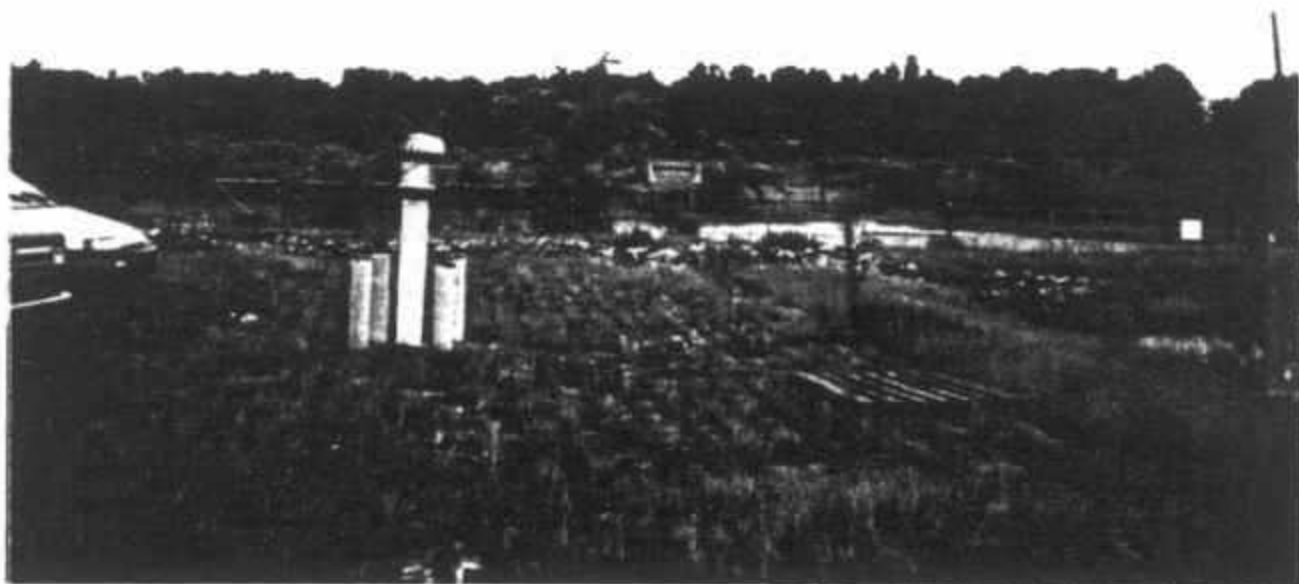
Photograph #1

Description: View looking north, from concrete block area in northeast corner of the PRLS. Realco Landfill and Pickettville Road in background, site entrance on left, Pond #1 on right, Ditch #1 and gas vent in foreground.

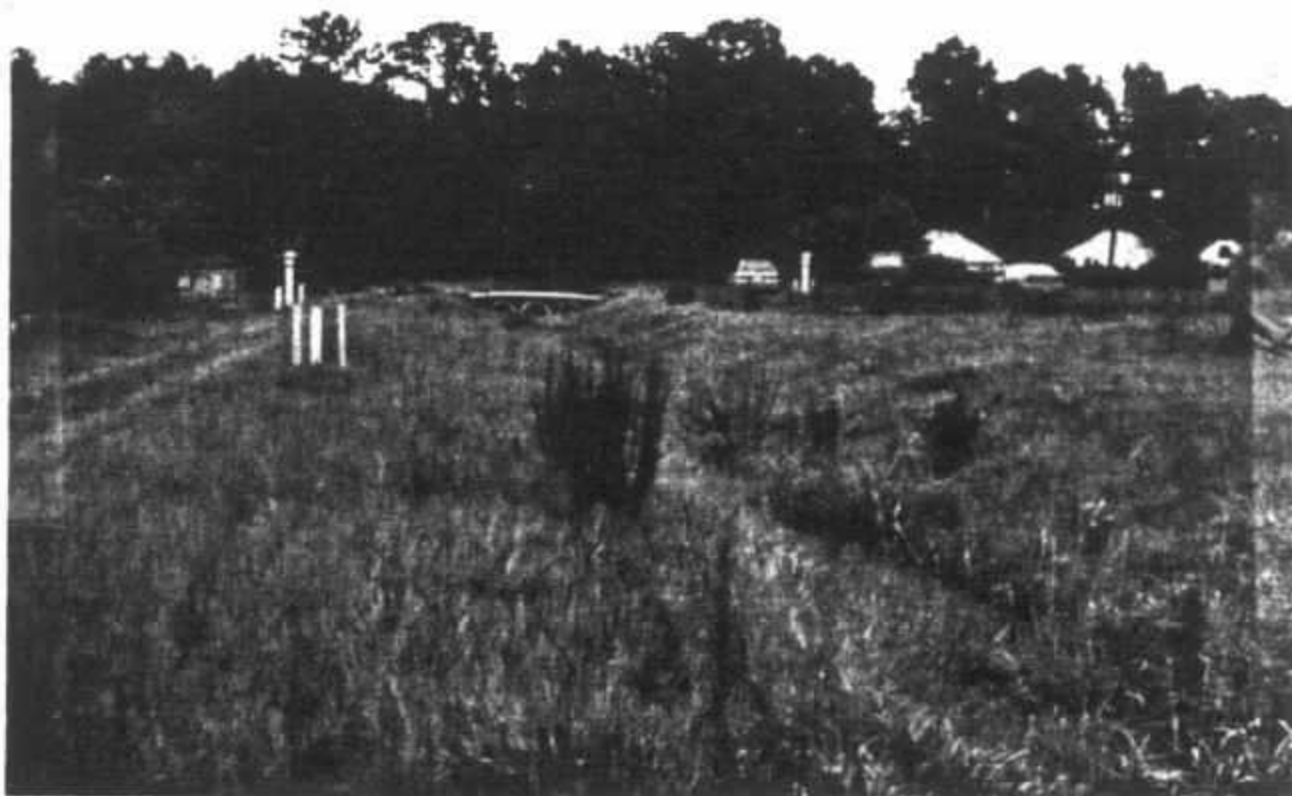
Photograph #2

Description: View looking northeast toward Pond #1. Northeast boundary and site entrance culvert in background, Drainage Ditch #1 on right, gas vents and monitoring probe on left, adjacent to northern boundary.

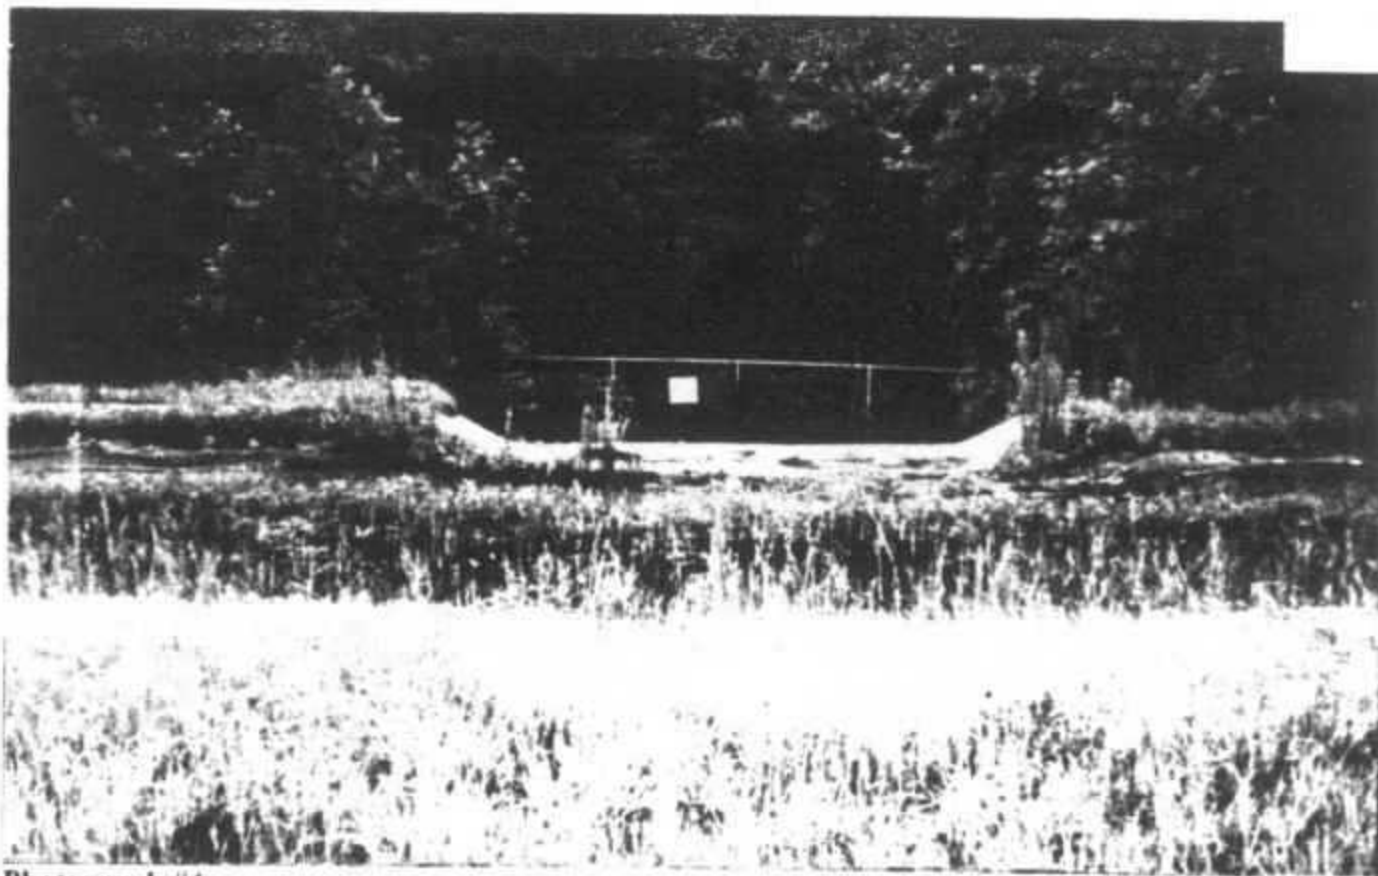
Photograph #4

Description: View looking east toward Pond #2 and concrete spillway which discharges to Little Sixmile Creek during high water conditions.

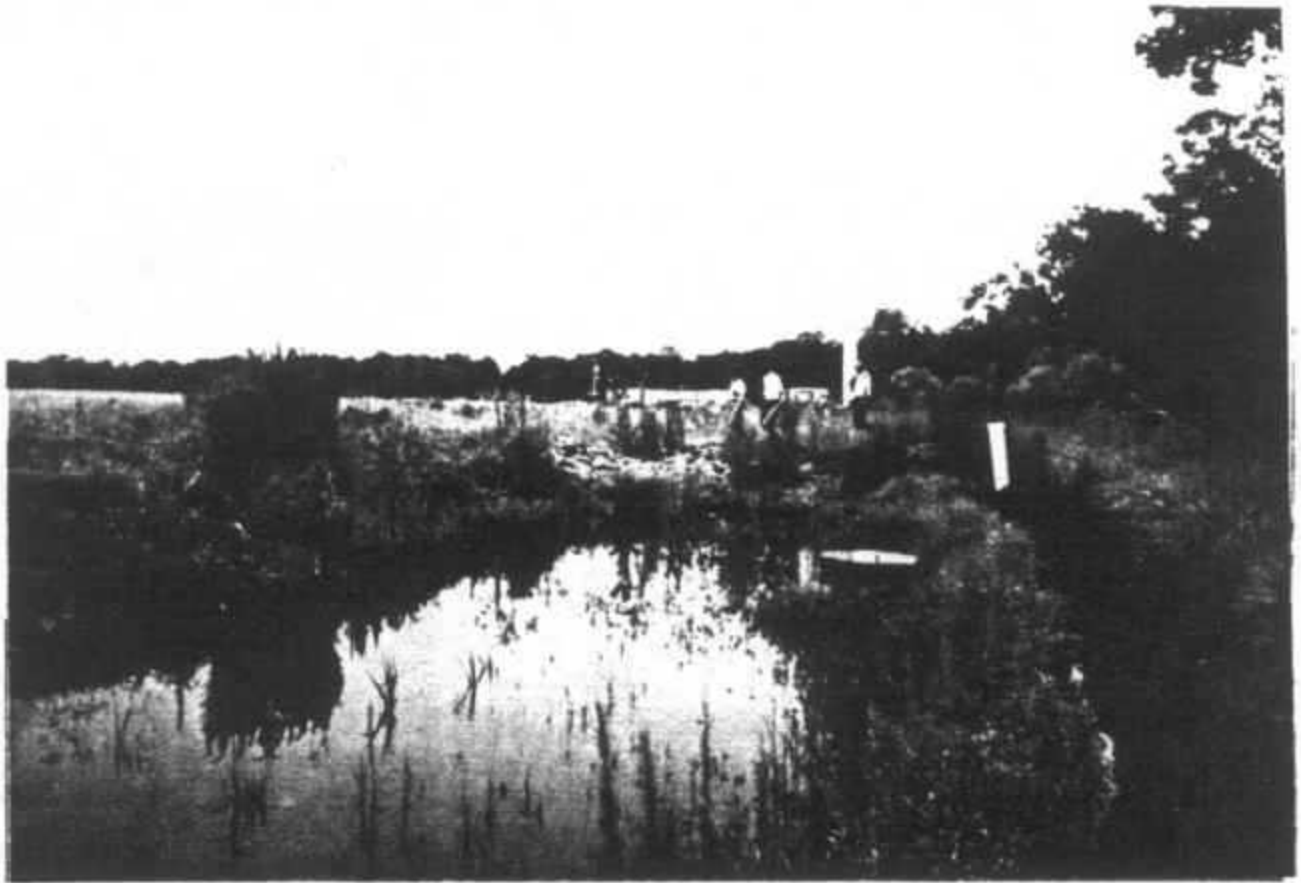
Photograph #5

Description: View looking north at northern edge of Pond #2. Note the above water portion of a 24 inch drain pipe which discharges to Little Sixmile Creek. Note exposed band of filter fabric on right.

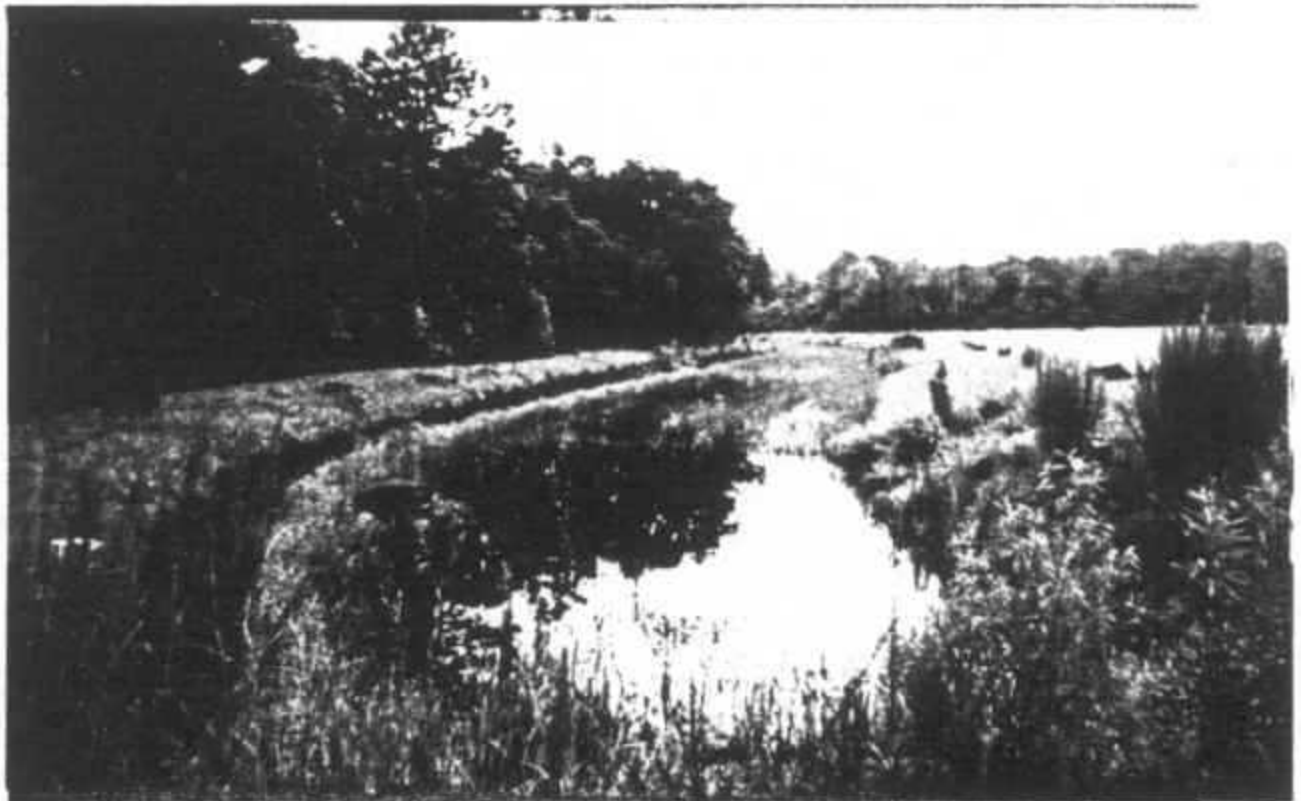
Photograph #6

Description: View looking south at Pond #2 from the northern edge of the pond.

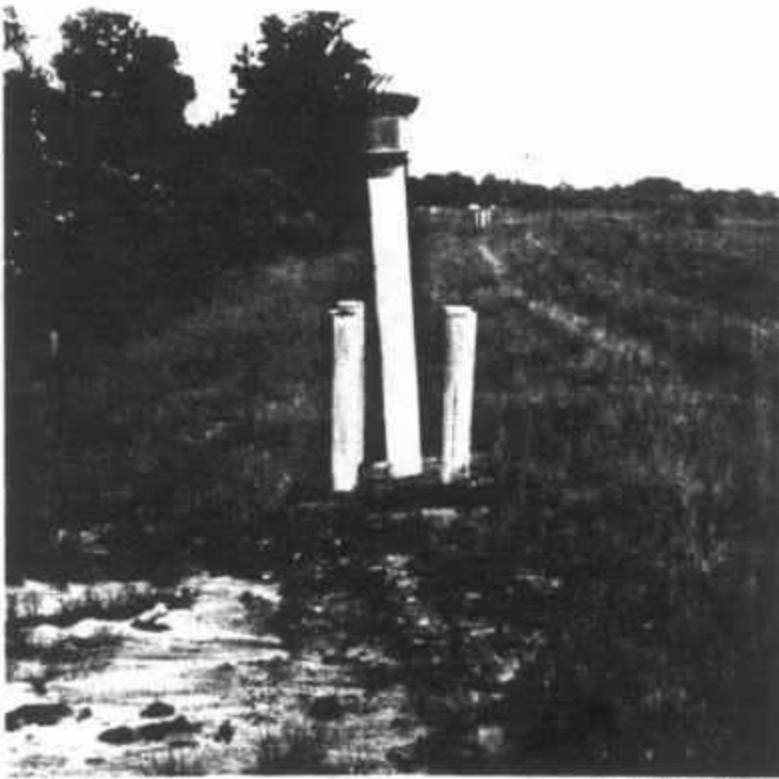
Photograph #9

E. A few of the vent risers located on the northwest side of the landfill were noted to be leaning somewhat from vertical. Although currently scheduled for replacement, two damaged/missing gas vent turbines were not replaced/repared within the 60 day time frame required under 62-701.620(7) F.A.C.

Description: Land fill gas vent. Several gas vents are leaning somewhat from vertical, such as the one shown here.

E. Continue to periodically inspect vent risers that are leaning to ensure that no damage has occurred to either the underlying geosynthetics or perforated pipe connection. Comply with the 60 day requirement for repair/replacement of damaged monitoring devices, unless written exception is obtained from Florida Department of Environmental Protection (FDEP), per 62-701.620(7) F.A.C.

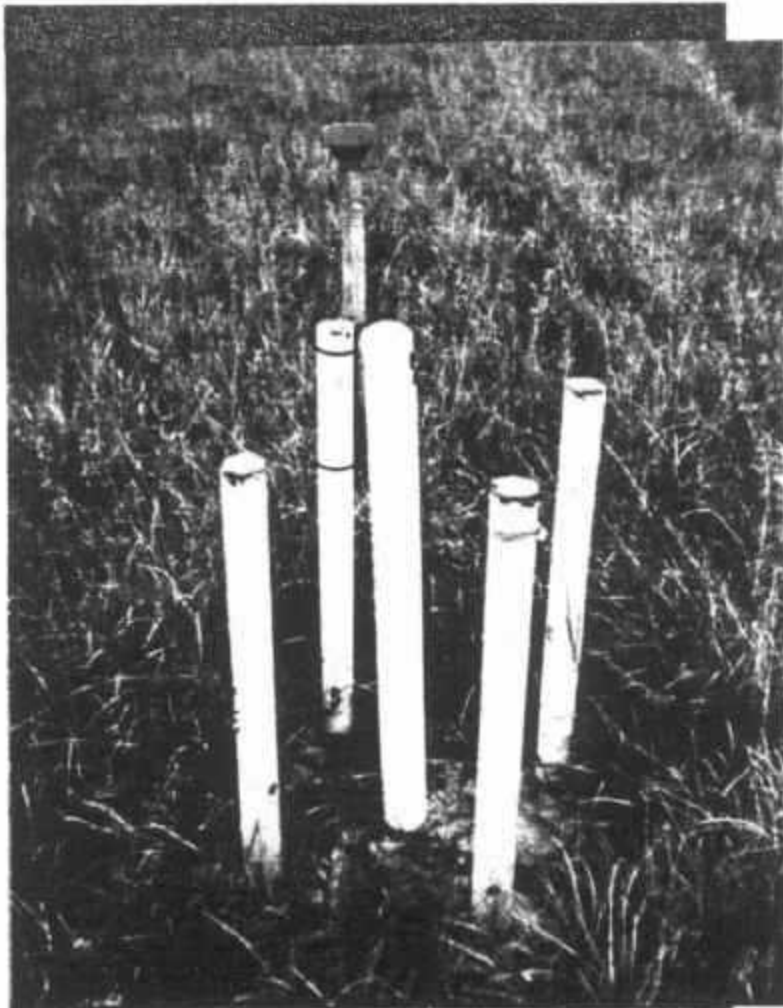
Photograph #10

Description: Typical gas monitoring probe and rain gauge. Gas monitoring probes are located on either side of the gas collection trench.
